SPACE SHUTTLE PROGRAM
Space Shuttle Propulsion Office (MSFC)
NASA Marshall Space Flight Center, Huntsville, Alabama

Reusable Solid Rocket Motor **STS-114 Flight Readiness Review/CoFR**

Motor Set RSRM-92

29-30 June 2005

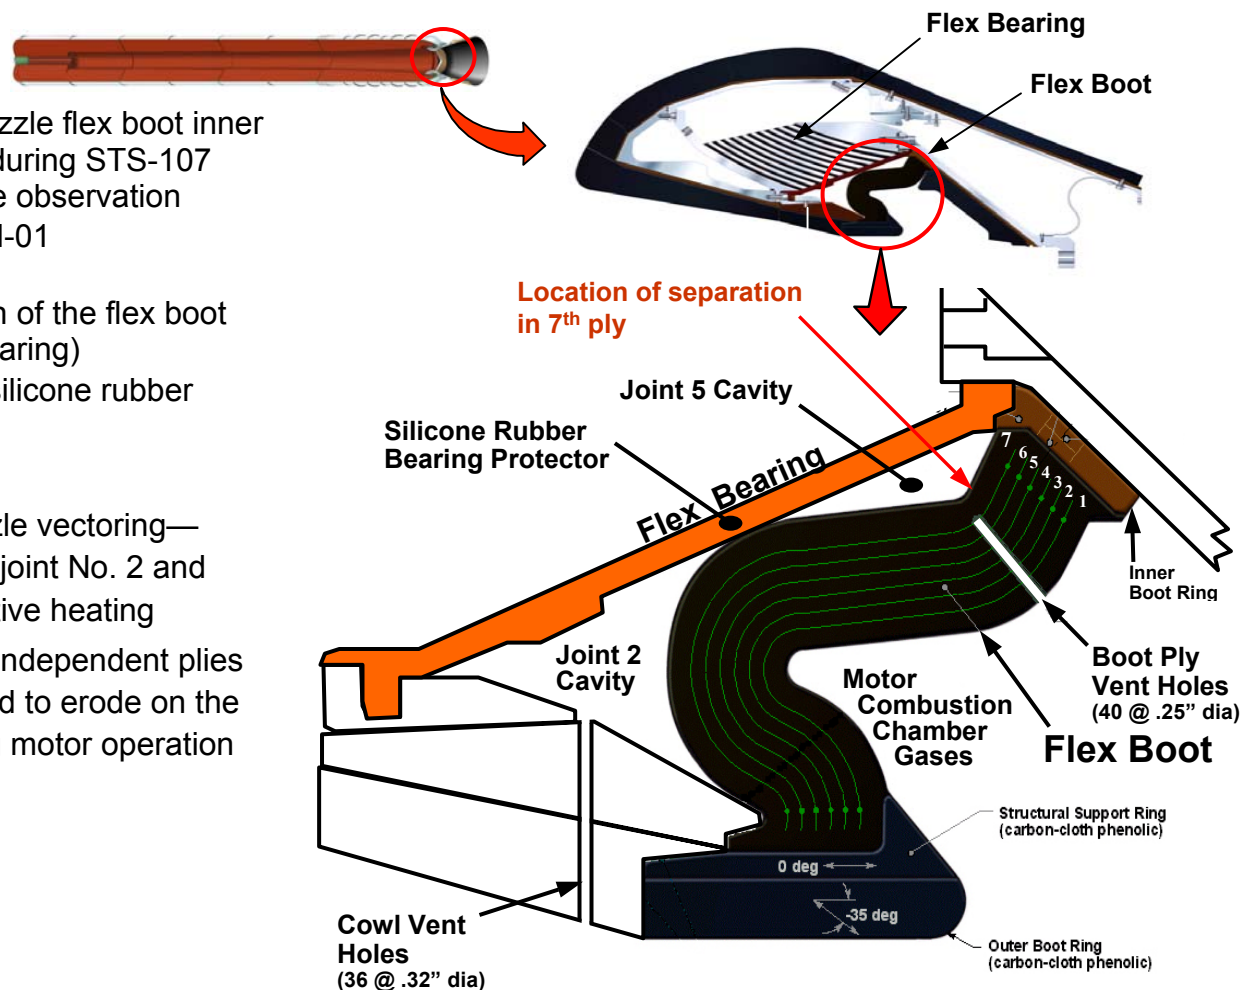
- A 57-in. separation of the RH nozzle flex boot inner (seventh) rubber ply was noted during STS-107 postflight disassembly—first-time observation
 - Elevated to IFA STS-107-M-01 (20 Feb 2004 PRCB)
- Separation did not affect function of the flex boot (thermal protection of the flex bearing)
 - No heat affect to adjacent silicone rubber bearing protector

- Rubber boot “flexes” during nozzle vectoring—protects flex bearing and nozzle joint No. 2 and No. 5 from convective and radiative heating
- The boot is comprised of seven independent plies of rubber—the rubber is designed to erode on the combustion chamber side during motor operation

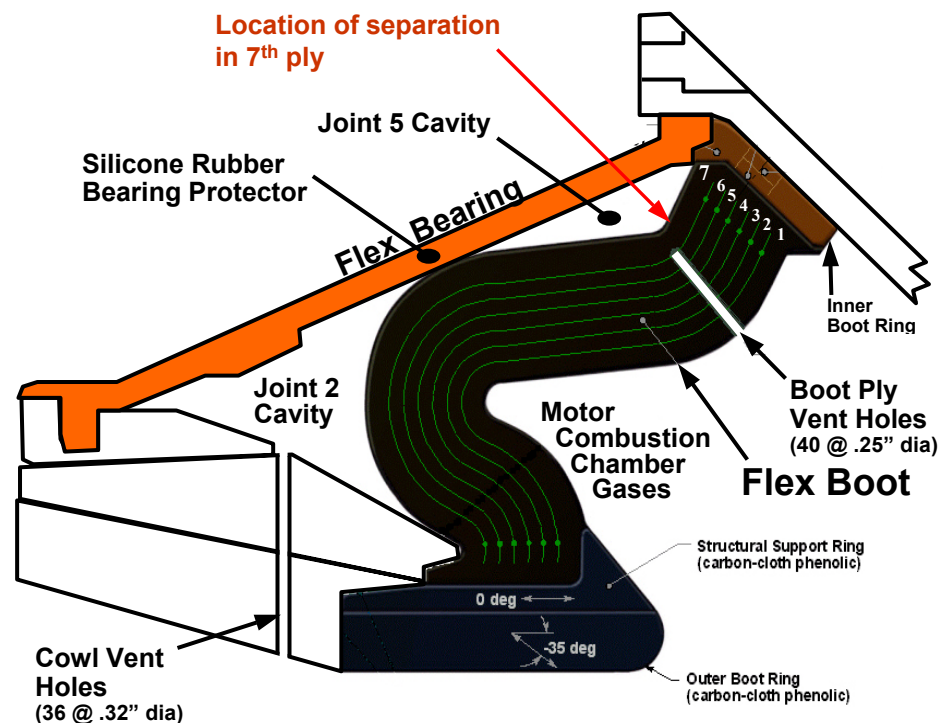
- Plies are vented via forty 0.25-in.-diameter holes to reduce stiffness of boot during motor operation
- Each ply is comprised of multiple 0.10-in. vulcanized layers

Ply 1	4 layers
Plies 2-6	3 layers in each
Ply 7	<u>Varies</u> from 3.5-5.5 layers

- Number of layers in seventh ply are varied to meet overall boot thickness requirements while precluding interference with the bearing protector and flex bearing (assembly fit-up)

- Fault tree approach used to guide investigation
- Cause understood—localized thermal degradation of seventh ply during motor operation *coupled* with end-of-motor operation depressurization strain loading (strain loading also occurs at splashdown) *and* a thinner than normal seventh ply
- Special cause factor associated with STS-107 RH boot—seventh ply was thinner than normal (one of only two 3.5-layer seventh ply boots flown—STS-113 seventh ply did not separate)
- All remaining boots in inventory have four or more layers in the seventh ply
 - No four-layer boots have exhibited a seventh ply separation (*includes eight flown and two static tested*)—*static testing includes recent ETM-3 margin test*
 - RSRM-89 RH boot with four layers in seventh ply did not exhibit separation in FVM-1 static test
 - STS-114 RH (RSRM-92B) has the only remaining four layer seventh ply boot that will fly

- Cause of STS-107 RH flex boot separation is understood
 - Thinner than normal seventh ply (3.5 layers) was locally degraded by slag heating
 - Thermal degradation increases with time—failure not possible early in burn

- Mechanical loading conditions for separation can occur only at motor depressurization or splashdown
- No separations have been noted in boots with four or more layers in seventh ply—all remaining flight inventory boots have four or more layers in seventh ply

- STS-114 RH (RSRM-92B) has the only remaining four layer seventh ply boot that will fly
- Bounding thermal analyses with slag heating inside boot cavity for entire burn duration show positive thermal margins at joint No. 2 and No. 5 primary seals

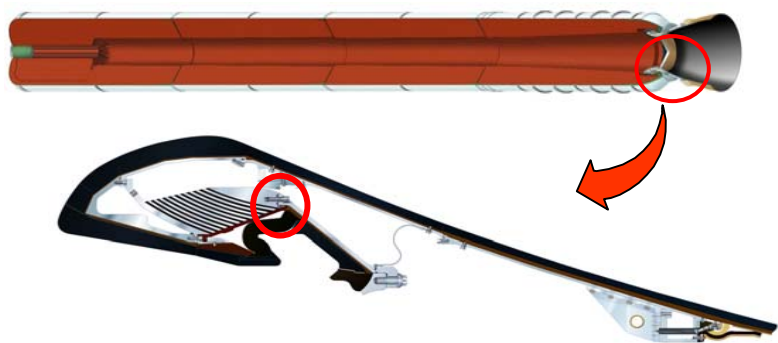
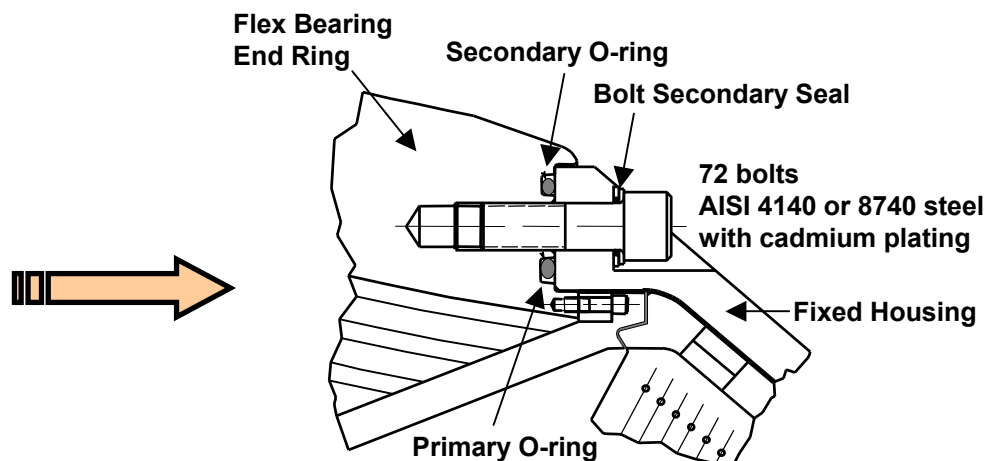
- PRs AB-BI125-0002 [STS-114 (RSRM-92)] and SB-BI124-0020 [STS-121 (RSRM-90)] have been written against four RSRM nozzles for corrosion on the nozzle joint No. 5 bolts. Corrosion is in the head-wrenching element

- Corrosion of high-strength steel raises a concern for degradation of bolt capability due to net section loss and/or environmentally-assisted cracking (stress corrosion cracking or hydrogen embrittlement) and subsequent bolt failure

Example of heavy corrosion in Joint No.5 bolt head wrenching element

- Mapping of STS-114 (RSRM-92) and STS-121 (RSRM-90) joint No. 5 bolt corrosion over visible 180-deg arc showed 20-to-80 percent of bolts corroded
- Approximately half of corroded bolts characterized as having medium corrosion with approximately equal numbers characterized as having heavy or light corrosion

- Corrosion condition evident on joint No. 5 bolts is bounded by both beach test data and exposure to laboratory induced low pH environments
 - No evidence of SCC in severe beach environment specimens with similar grain orientation and loading levels set near 100 percent of yield strength

- No evidence of SCC in laboratory bolt specimens at pH levels as low as 4.0—step loaded to failure
 - Joint No. 5 bolt grain flow and stress state (40 percent of yield) preclude SCC

- Worst-case loss rate of bolt cross-section due to corrosion will not result in bolt failure over 5-year period in KSC storage/assembly environment
 - Interaction of potential failure modes has been assessed with no concerns noted

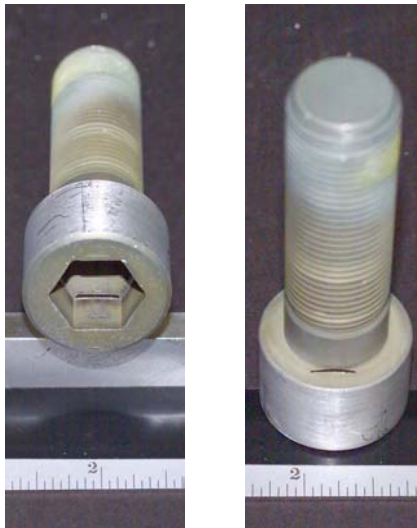
EDM Notched Bolt

- Residual capability test, simulating a crack completely through one of six bolt-wrenching element plains, showed bolt heads to be fault tolerant
 - Electron discharge machined (EDM) flaw at the bottom of the socket head to the head/shank radius—approximately 0.35 in. wide by 0.3 in. deep
 - Four bolts pulled to failure and all bolts broke in the head at loads greater than 70 kips—minimum specification limit is 63 kips, maximum preload is 54 kips

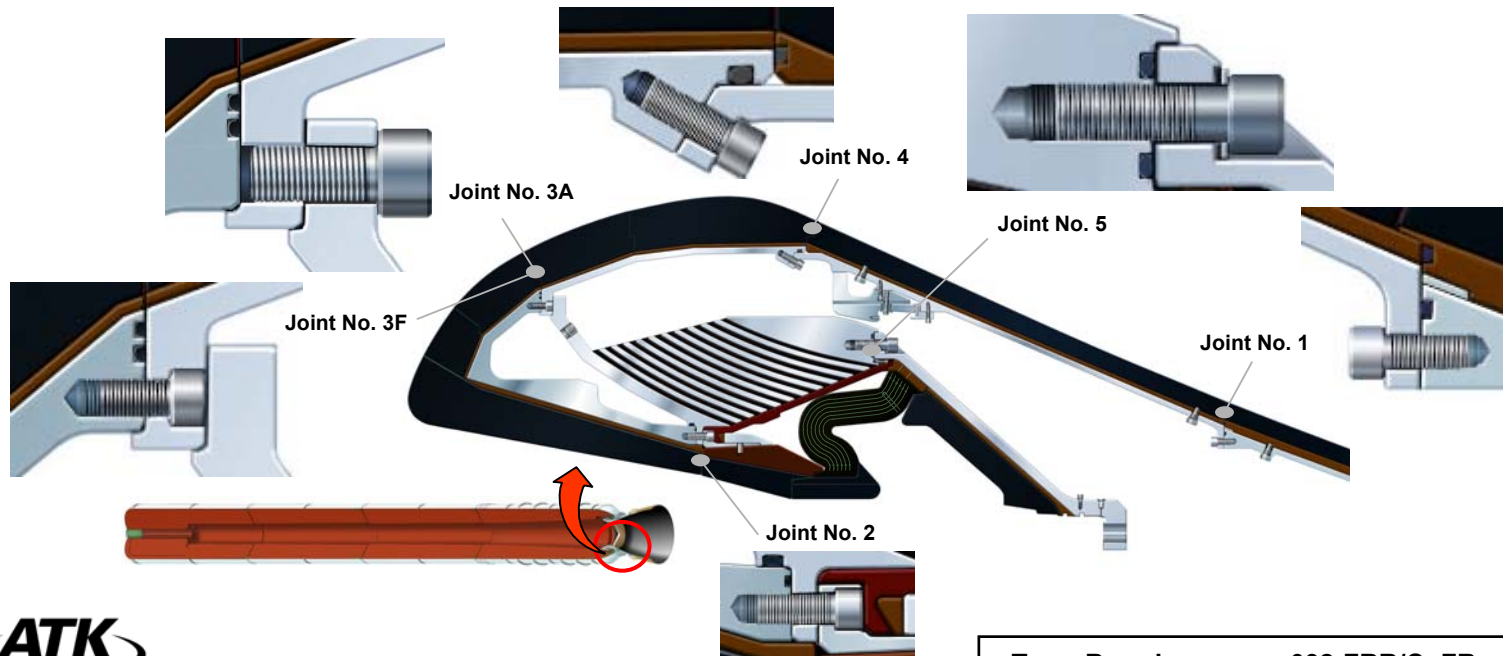
- All nozzle joints are fault tolerant with respect to bolt failure
 - Compressive operational loads are carried across nozzle joints
 - Joint No. 5 seal tracking ability assured with a pattern of three bolts out—one bolt in
- Joint No. 5 represents bounding case for nozzle joint Nos. 1, 3F, 3A, and 4 which use bolts of the same material
 - Joint No. 5 is the only opening joint
 - Only joint in which bolt stress increases during motor operation
 - Only joint with a secondary seal provided by packing-with-retainer
